**Trans Mountain Pipeline ULC (“Trans Mountain”)
NEB filing under OM2018-214 (A92155)
Filed on 29 May 2018**

Information Request No. 1

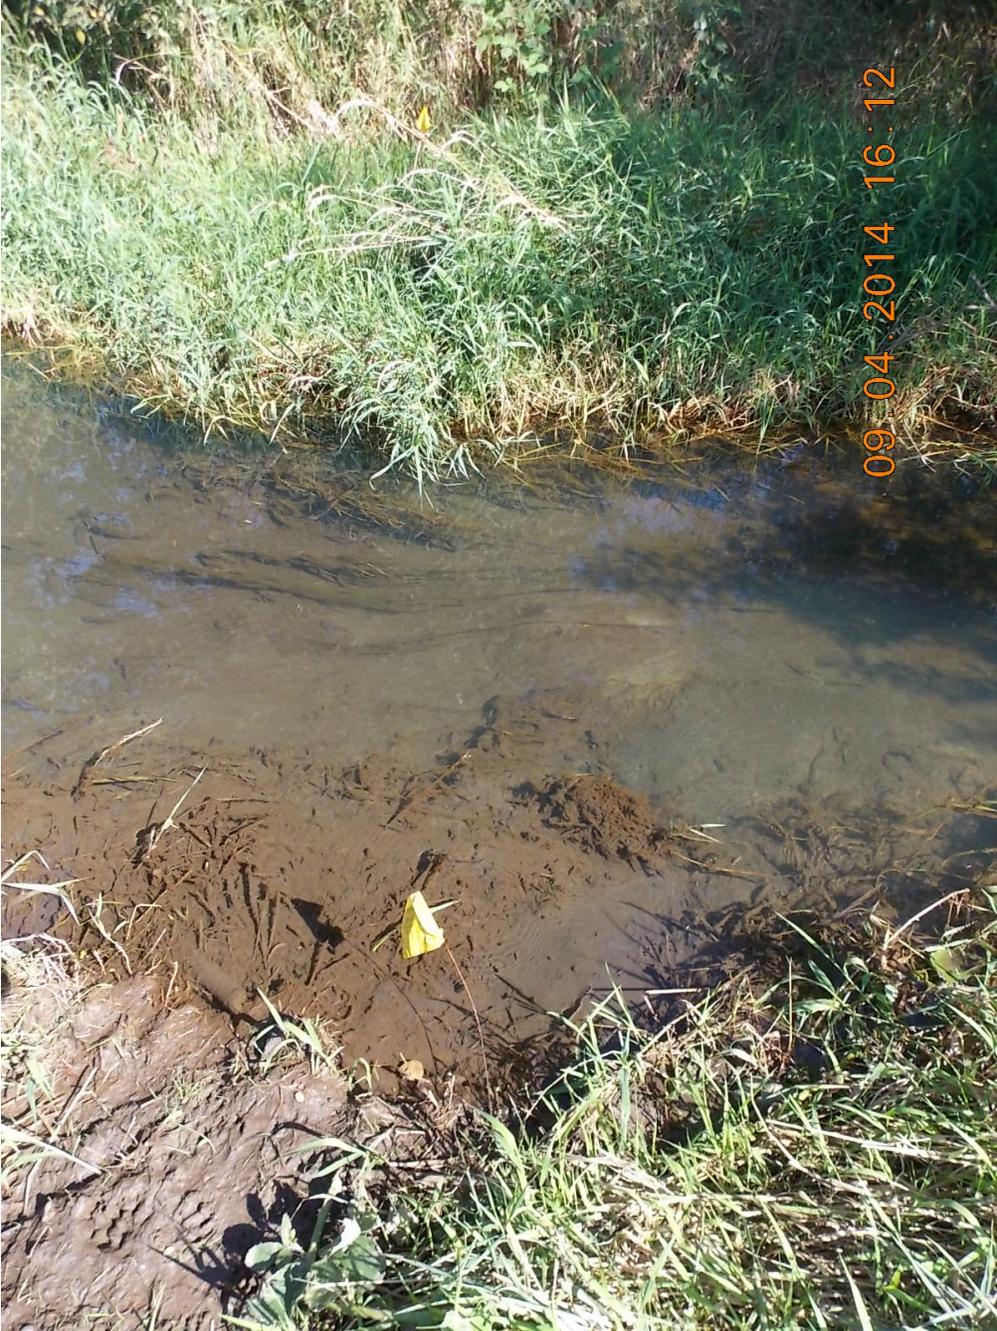
1. Trans Mountain did not file an incident report when the exposure was first detected in 2010 as it predated the issuance of the *NEB Event Reporting Guidelines*. The pipeline is exposed for the width of the channel and a concrete weight covers the pipeline near the west bank. Trans Mountain prioritizes hazard abatement works for watercourse crossings based on risk ranking. The probability of exposure and the risk of damage or failure if the pipeline were to become exposed are taken into consideration for determining this ranking. For the Stewart Slough crossing, the pipe is already exposed and there is no risk of damage or failure of the pipe from exposure to the watercourse elements or flow velocity. As such, this site has been ranked as ‘Medium Priority’ for mitigation. The only risk to the exposed pipe is potential damage by third-party ditch cleaning equipment. To minimize this risk, Trans Mountain has required that any work over and near the pipeline must be undertaken by hand digging with a Company Pipeline Protection Inspector present. There are also pipeline markers identifying this crossing with contact numbers. Multiple in-line inspection tool runs have also not revealed any potentially injurious features at this water crossing.

the pipeline. The assessment identified that long term bed scour and degradation had lowered the creek bed to result in exposure of the 24" diameter pipeline and concrete weights.

On the right bank looking at the left bank along the pipeline centerline:

Recommendation was provided for the exposed pipeline to be covered with concrete articulating mats (i.e. ArmorFlex) with a design to withstand shear stress for the 200-year flood peak. An analysis and hydraulic model of the watercourse hydraulics at the pipeline crossing was undertaken to determine specifications for the matting. The remediation design includes excavation to fully expose the pipeline followed by installation of a protective pipe coating layer, sand cushion, select backfill material, and concrete articulating mats through the pipeline crossing site. The concrete articulating mats (ArmorFlex Open Cell Class 40 or equivalent) will be placed in the channel and extend approximately 8 m upstream and 9 m downstream of the exposed portion of the pipeline. Additionally, 2.0 m long and 0.7 m deep keys will be constructed at the upstream and downstream edges of the mats and overlain with riprap.

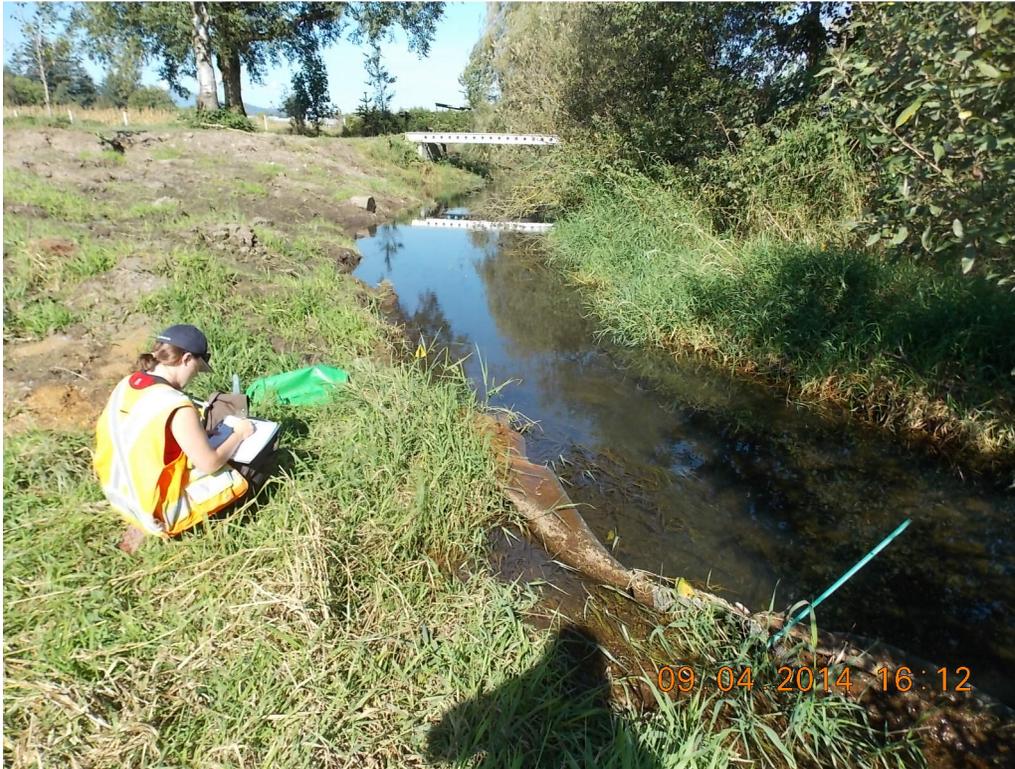
On the right bank looking upstream with the pipe locator on the centerline:

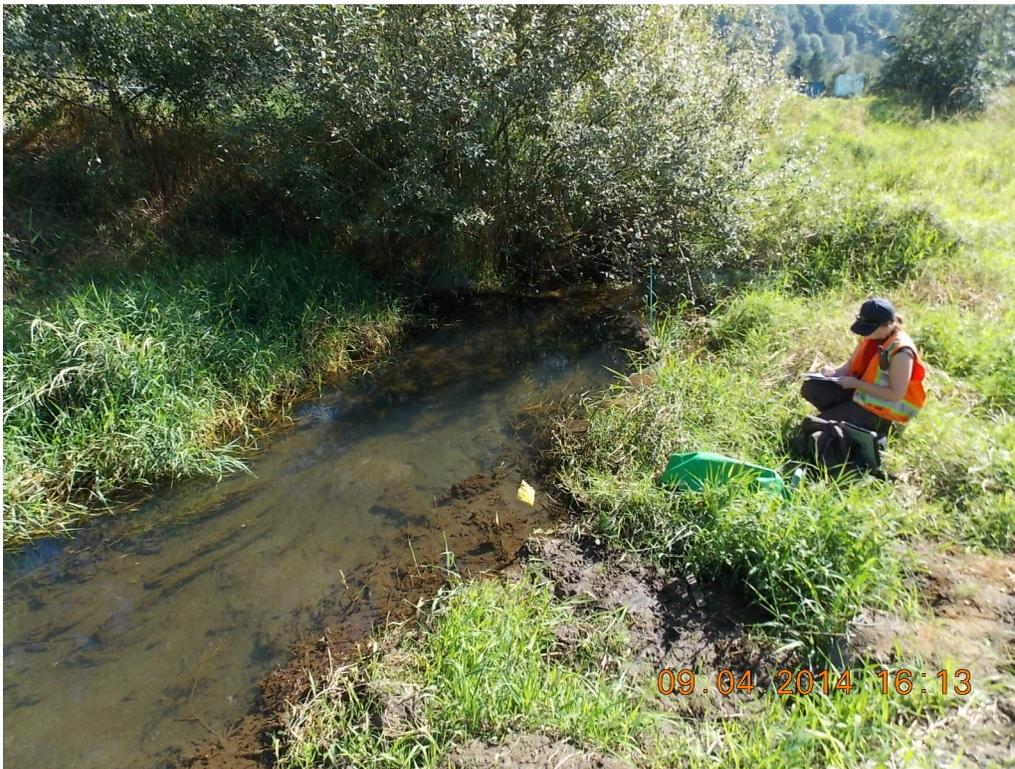
On the right bank looking downstream with the pipe locator on the centerline:

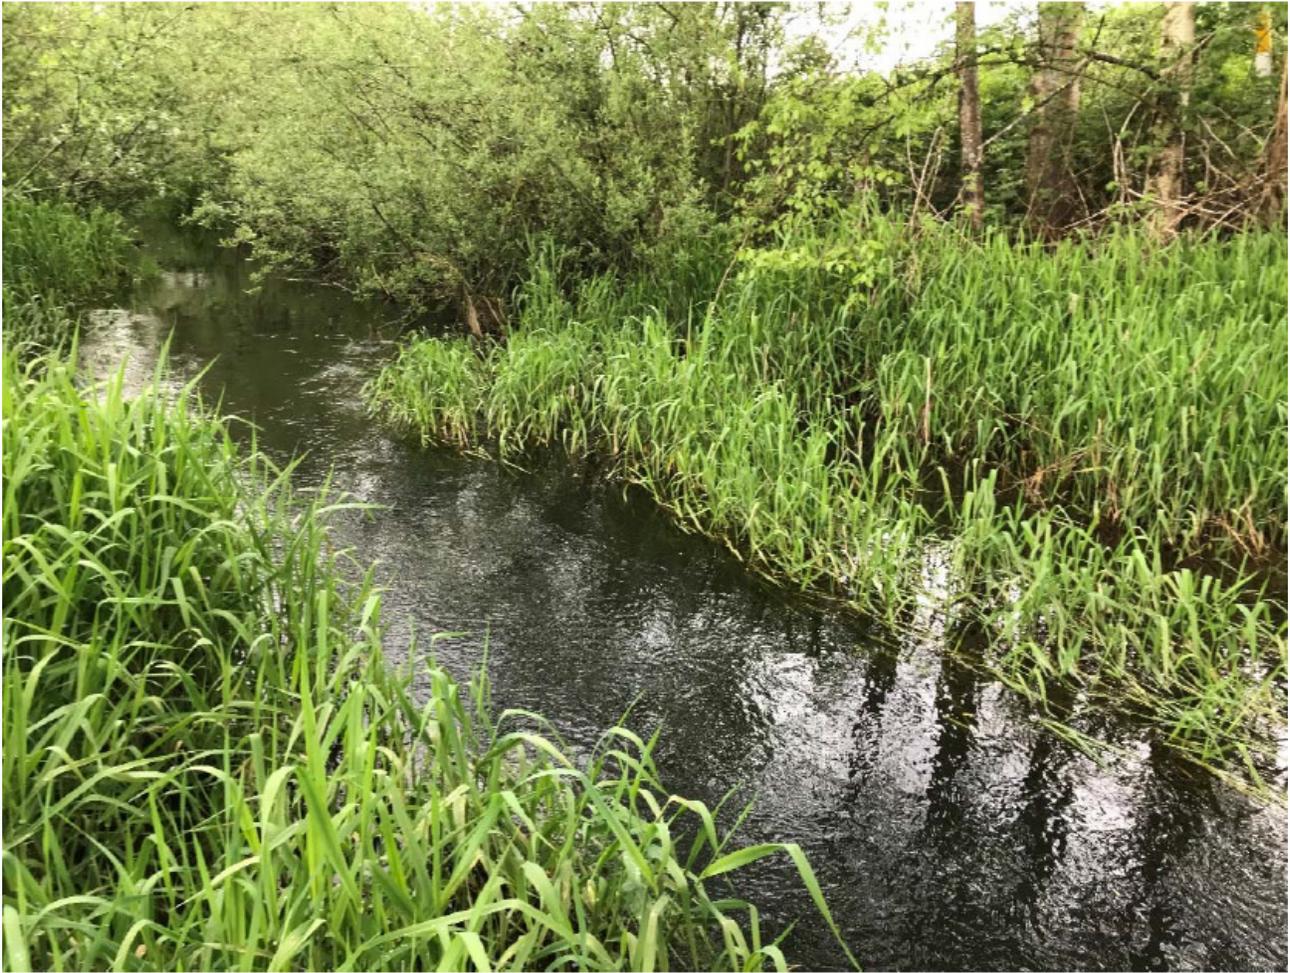
Upstream view (northeast aspect) Stewart Slough at the Trans Mountain right-of-way ("ROW") crossing (pipeline marker is visible in background on right of frame). Photograph reference: Environmental Overview Assessment and Mitigation Plan prepared by Sartori Environmental Inc. (April 30, 2018).

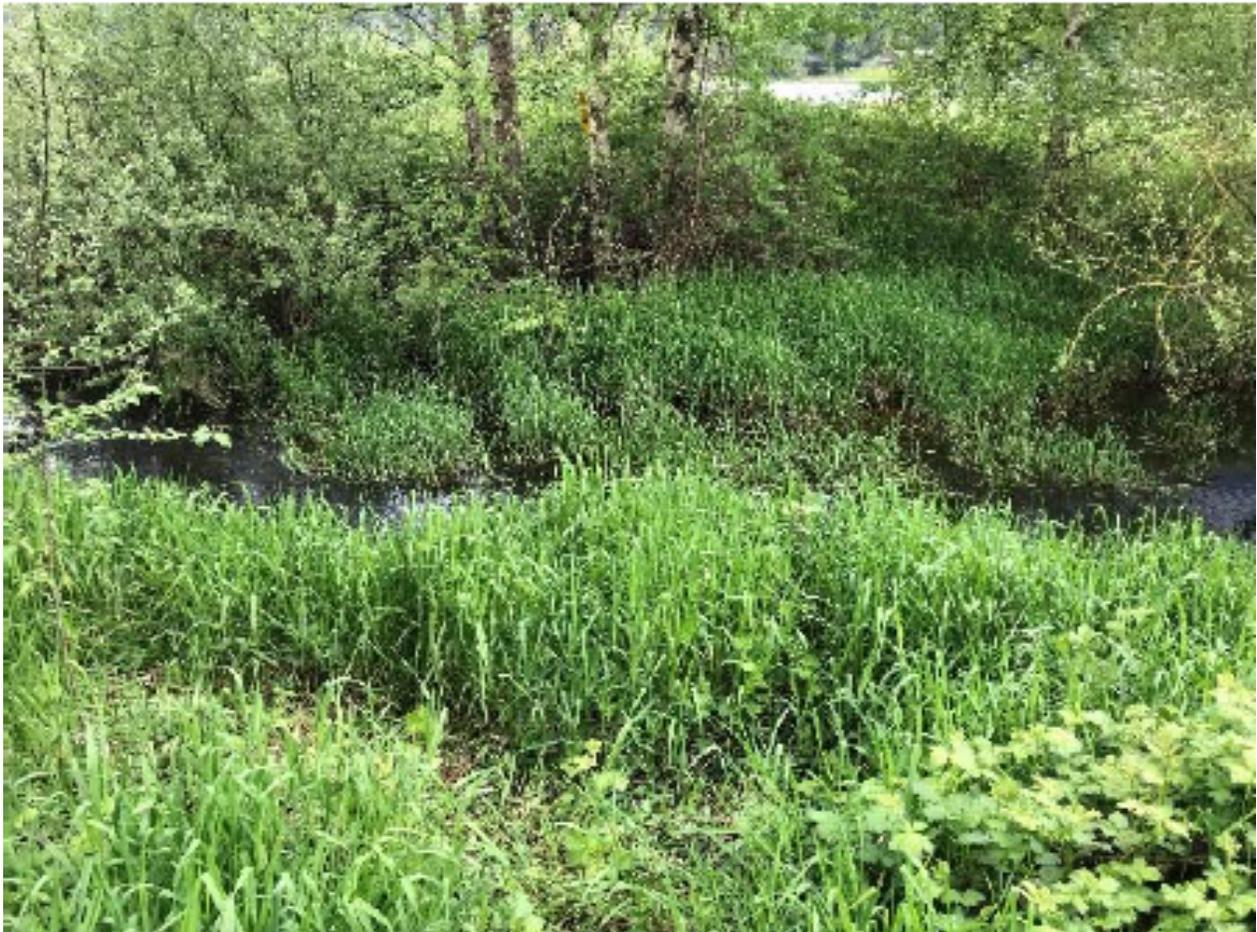
East aspect of Stewart Slough taken from top of right bank at the Trans Mountain ROW crossing (pipeline marker is visible in background). Photograph reference: Environmental Overview Assessment and Mitigation Plan prepared by Sartori Environmental Inc. (April 30, 2018).
