Trans Mountain Expansion Pipeline

Pipeline Reactivation

NPS 24 Hinton to Hargreaves and NPS 24 Darfield to Black Pines

Engineering Assessment

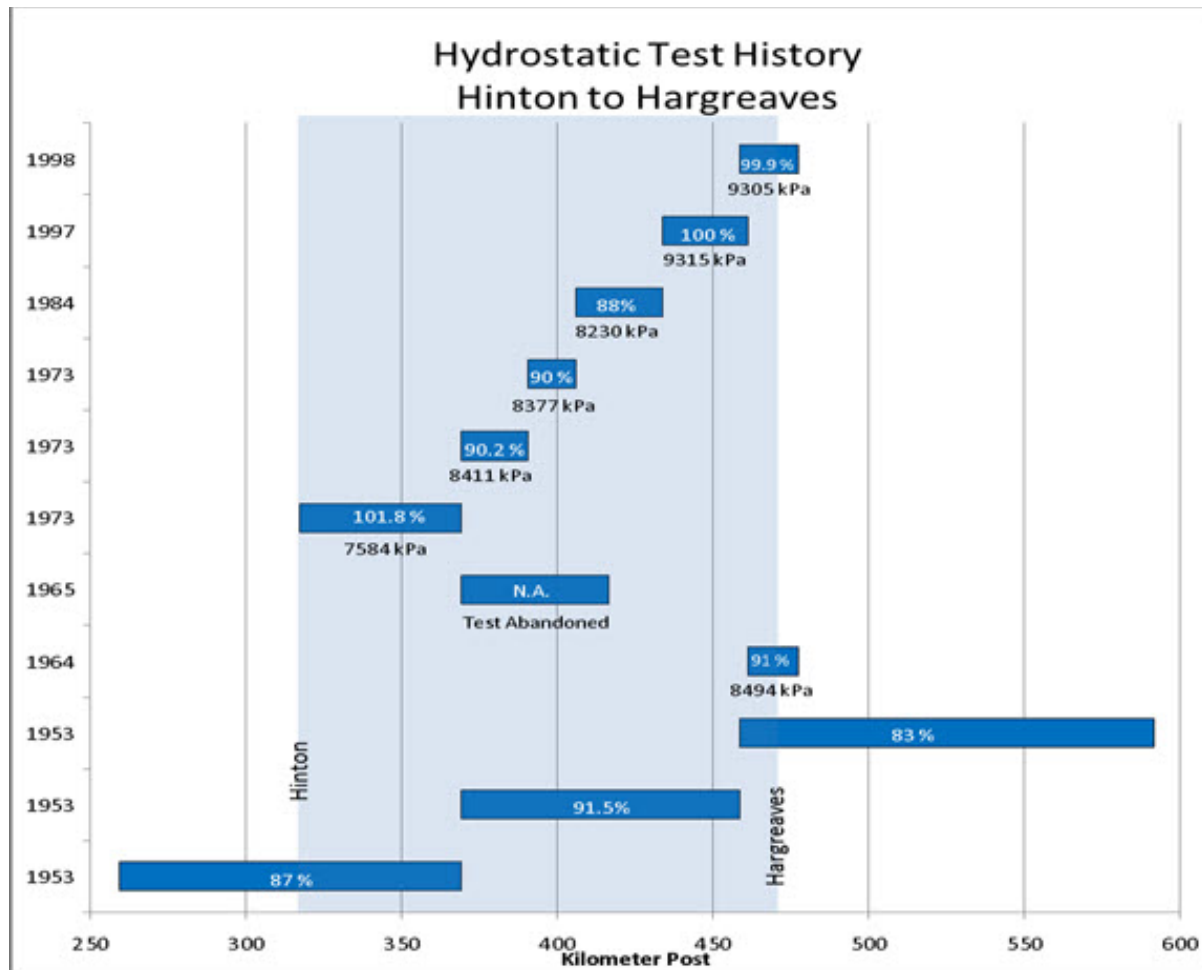
Figure 4.5.1 Hydrostatic Test History – Hinton to Hargreaves

4.5	Text was revised to correct the hydrostatic test history for the 1965 hydrostatic test and to include the cause of the test failures associated with the 1965 hydrostatic test.

4.5	Original Figure 3.6.1 Hydrostatic Test History – Hinton to Hargreaves. The figure incorrectly showed a 100% SMYS hydrostatic tests for the 1964-1965 tests. The errata was corrected in the Trans Mountain response to the NEB IR. The corrected figure is included in this engineering assessment as Figure 4.5.1 Hydrostatic Test History – Hinton to Hargreaves. The revised figure also includes the highest pressure achieved at the low point of the test sections.

The initial post-construction hydrostatic test for the Hinton to Hargreaves segment took place in 1953 (Figure 4.5.1). This segment was initially tested in three sections. The test pressures ranged from 83 to 91.5 per cent of the SMYS at the low points. No failures occurred as a result of these initial tests. Additional hydrostatic testing of the pipeline occurred in eight sections between 1964 through 1998 with a test pressure ranging between 88 and 101.8 per cent of the SMYS. Three failures occurred in the 1965 hydrostatic test. The 1965 hydrostatic test was ultimately abandoned and the pipe section was retested between 1973 and 1984. The cause of the test failures were determined to be due to gouges in the pipe body that occurred during original construction. No failures occurred in the other hydrostatic tests.

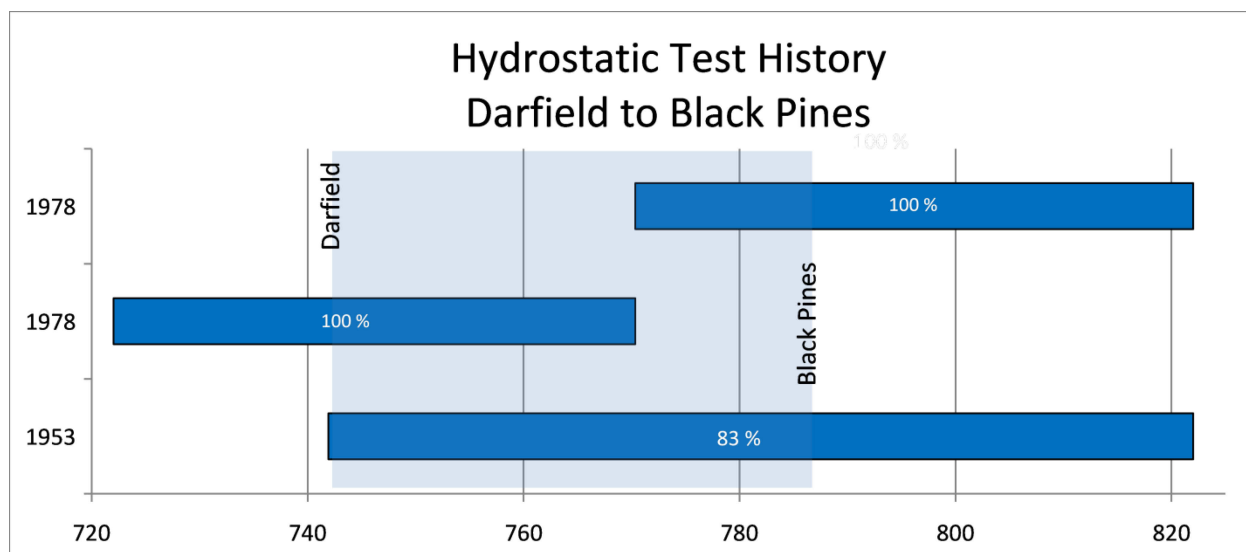
Figure 4.5.2 Hydrostatic Test History – Darfield to Black Pines

The initial post-construction hydrostatic test for the Darfield to Black Pines segment took place in 1953 (see Figure 4.5.2). The pipeline was initially tested in one section. The test pressure was 83 per cent of the SMYS at the low point. The segment was retested in two sections in 1978. The test pressure achieved was 100 per cent of the SMYS at the low point of the two test sections. No failures occurred in either of the test sections.
