**Re: NOVA Gas Transmission Ltd. (NGTL)
Liege Lateral Loop 2 (Thornbury Section) and
Leismer East Compressor Station (Project)
Order XG-N081-003-2015 (Order)
Condition 9: Caribou Monitoring Report
File: OF-Fac-Gas-N081-2014-11 01**

Enclosed, please see the Year One Caribou Monitoring Report for the Project.

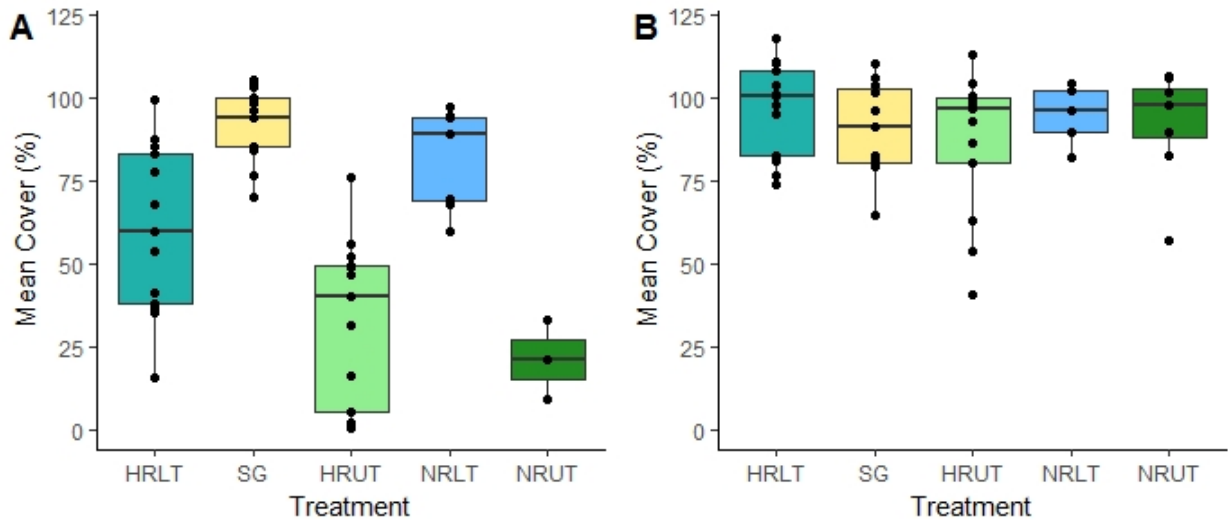
Figure 3-8: Distribution of percent covers \pm SE of native vegetation by restoration unit and Project Area. Note: Thornbury = A, Dillon = B. HR = Habitat Restoration, NR = Natural Regeneration, LT = Lowland Treed, UT = Upland Treed, SG = Shrub/Grainoid. The centre line in the boxplot indicates the median value.

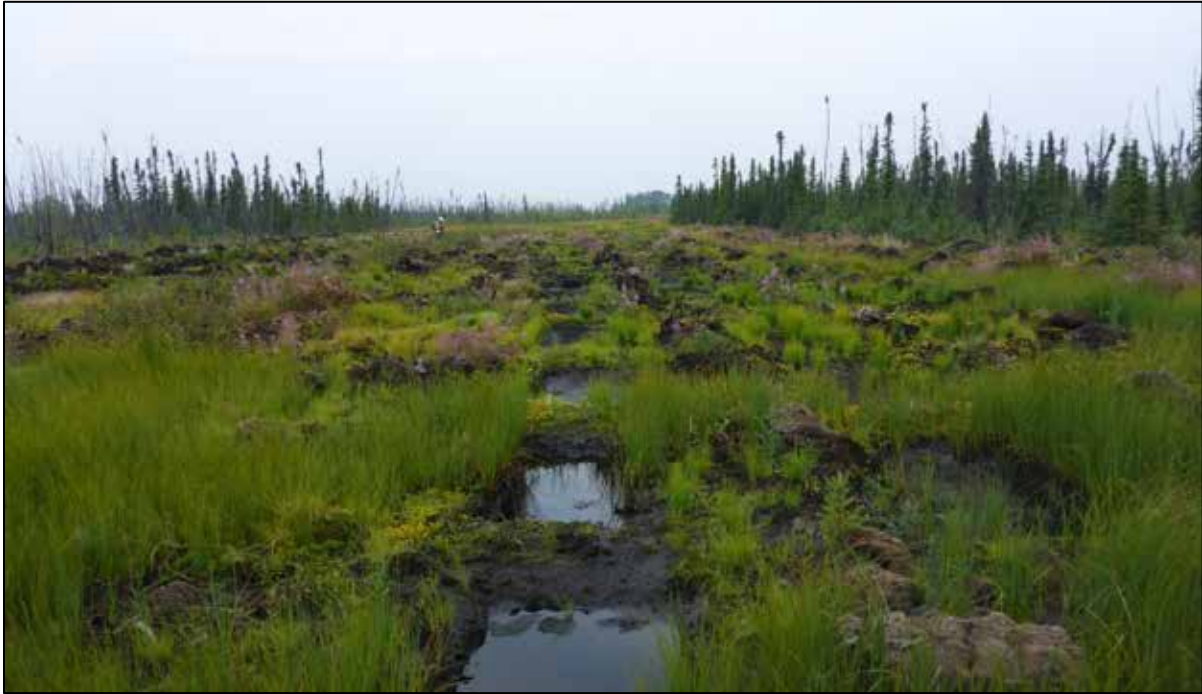
Low evidence of human access was observed circumventing access control or using parallel alignments to bypass access controls (Table 3-9). The ground-based monitoring **program** results indicate access control measures are intact and are performing as anticipated. Changes in access relative to baseline data collected in Year 1 of the program will be assessed in future years.

Figure 3-9: Example of mounded hummock and pool access control along Thornbury in wetland habitat. Many of the habitats described in this report present challenge to non-frozen access during summer. Winter access is captured by the remote camera program discussed in Section 4 of this report

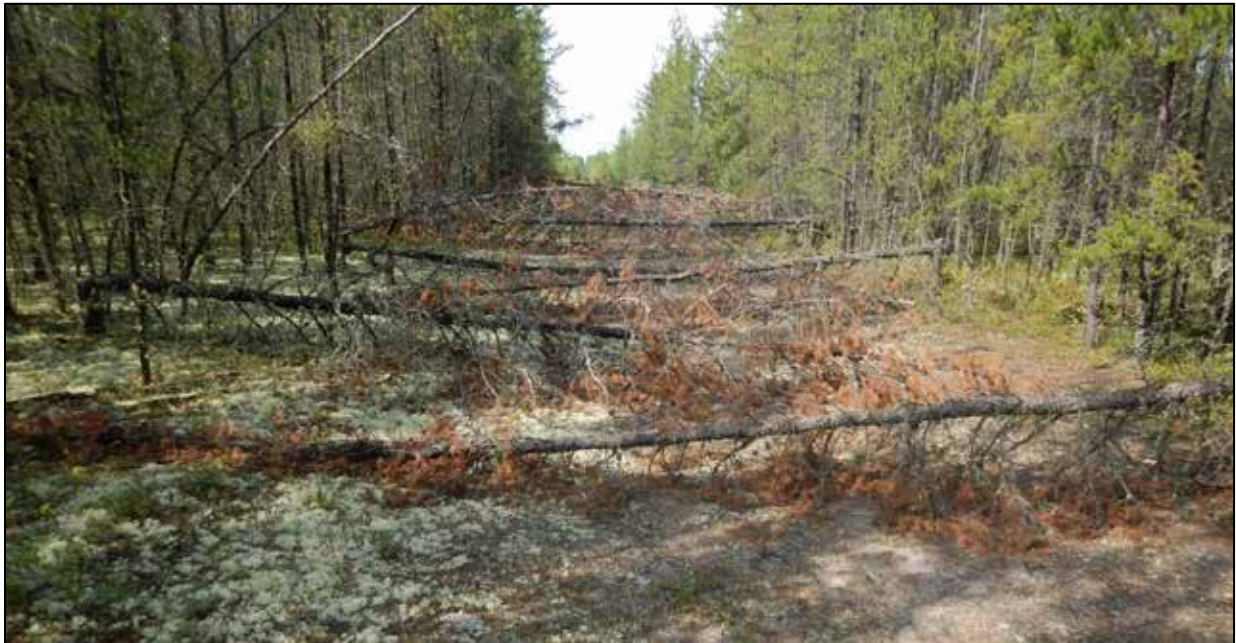
Access controls were not defined for the Dillon offsets due to the different nature of the area, which is characterized by extensive regenerating seismic development and limited access due to its remoteness. However, felled trees (coarse woody debris) were combined or interspersed with planting treatments where required (Photo 3-2) to limit access and, secondarily, to slow down or discourage potential predator movements along seismic lines. Special attention was paid to existing signs of traffic along lines.

Figure 3-10: Example of a relatively open seismic line on Dillon. In such locations, access controls were implemented as on a case to case basis according to NGTL vegetation specialists’ prescriptions as well as ongoing desktop research based on high definition aerial imagery. In the picture fallen coarse woody-debris deter access along a seismic line and block ground visibility

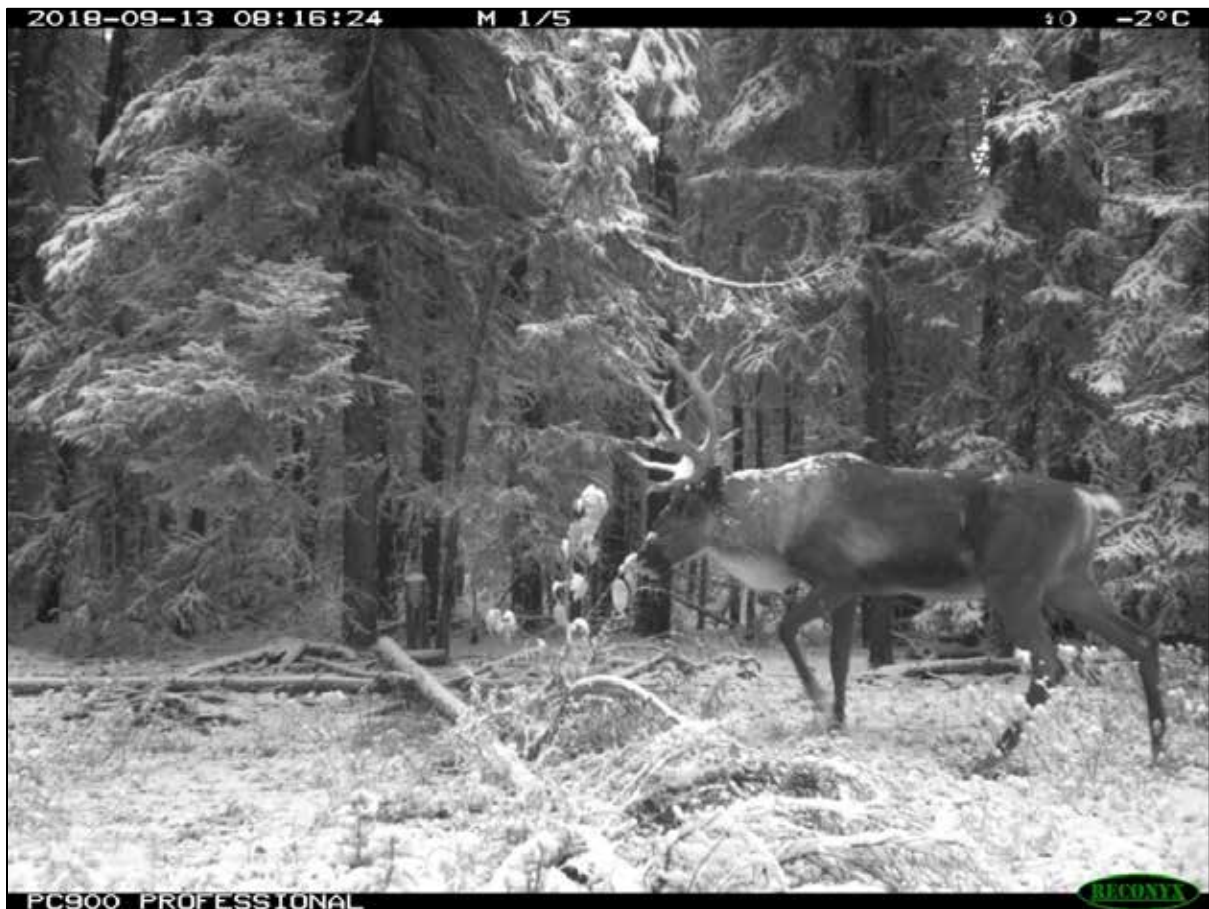
Figure 5-23: Caribou travelling along the seismic line within the Dillon offsets. The felled tree (access control) the Caribou is about to cross does not seem to pose immediate mobility problems.
