**Re: NOVA Gas Transmission Ltd. (NGTL)  
Northwest Mainline Expansion Project (NWML), Leismer-Kettle River Crossover  
Project (LKXO), and Chinchaga Lateral Loop No. 3 (Chinchaga) Project  
(collectively, the Projects)  
Certificates GC-119, GC-120 and GC- 121  
Year Three Caribou Monitoring Report**

Enclosed, please see the Year Three Caribou Monitoring Report for the Projects in accordance Condition 24 of NWML Certificate GC-119, Condition 19 of LKXO Certificate GC-120 and Condition 21 of Chinchaga Certificate GC-121.

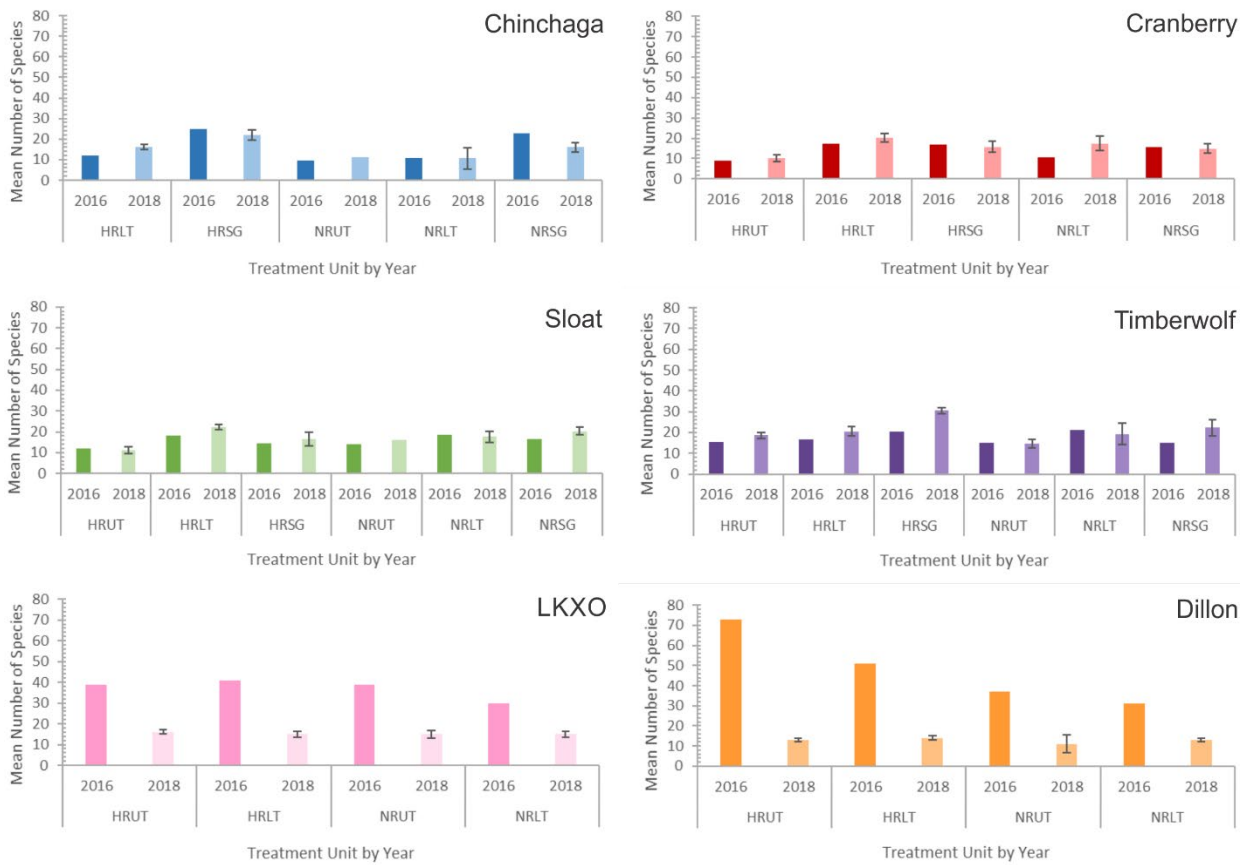
Species richness is defined as the diversity of species occupying a given area (Brown et al., 2016). The species richness of native vegetation observed within each restoration treatment unit for each year is presented in Figure 3-7.

**Figure 3-7: Species richness (mean number of species) by year, treatment and Project Area**

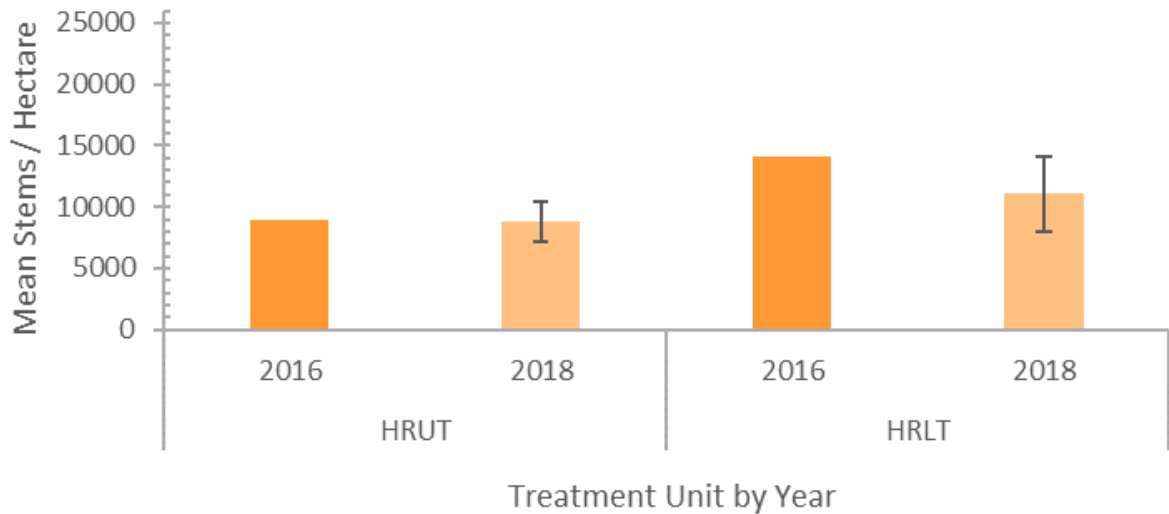
Average seedling stem density significantly exceeded ( $p < 0.05$ ) the stems/hectare targets for all restoration plots (Figure 3-13). As anticipated, average stems per hectare were lower in naturally regenerating plots and highly variable in naturally regenerating lowland plots. It is expected that naturally regenerating plots will approach target densities with the continued natural ingress of seedlings over a longer time frame. This process is expected to be even more accelerated within the Dillon Offsets relative to the other Project Areas due to the smaller footprint width and the considerations expressed in previous sections. Seedling density was comparable in habitat restoration plots between Year 1 and Year 3.

**Figure 3-13: Seedling density (mean stems per hectare) by treatment and year in Dillon**

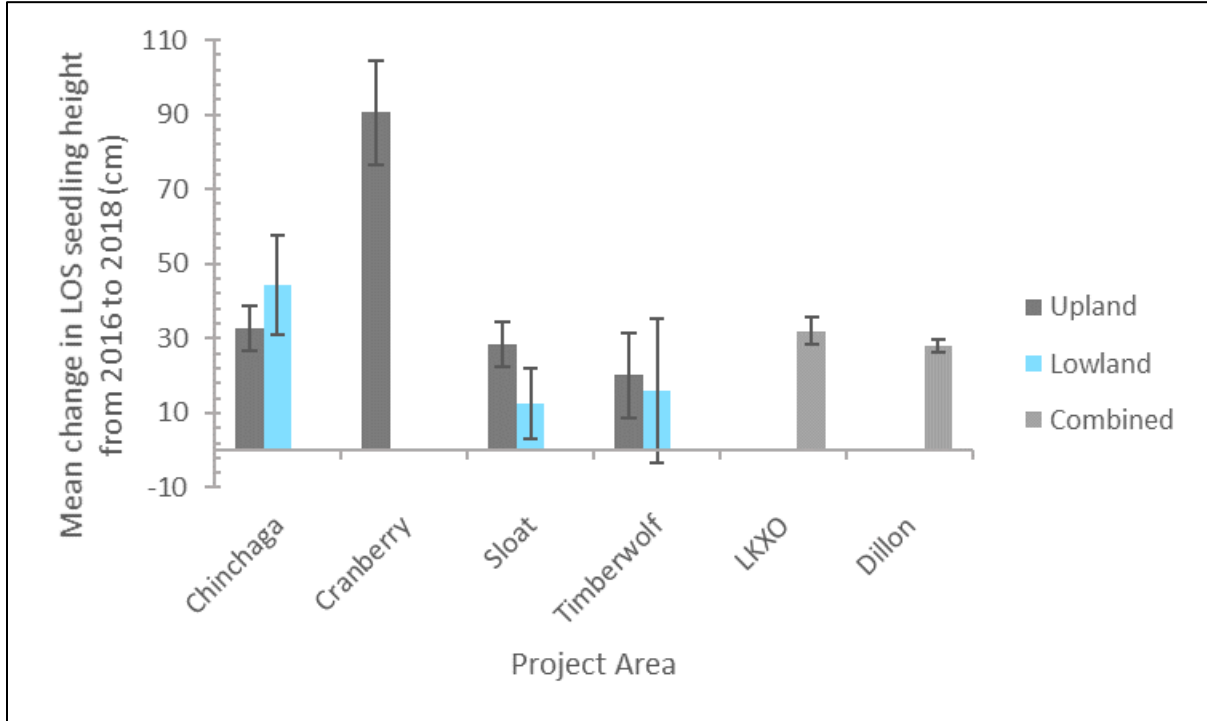
enough to provide effective line of sight blockage along the ROW, this capacity will increase over the course of the Monitoring Program and will continue to be assessed.

**Figure 3-16: Change in height (cm) between Year 1 and Year 3 for upland, lowland or combined LOS plots for all Project areas**

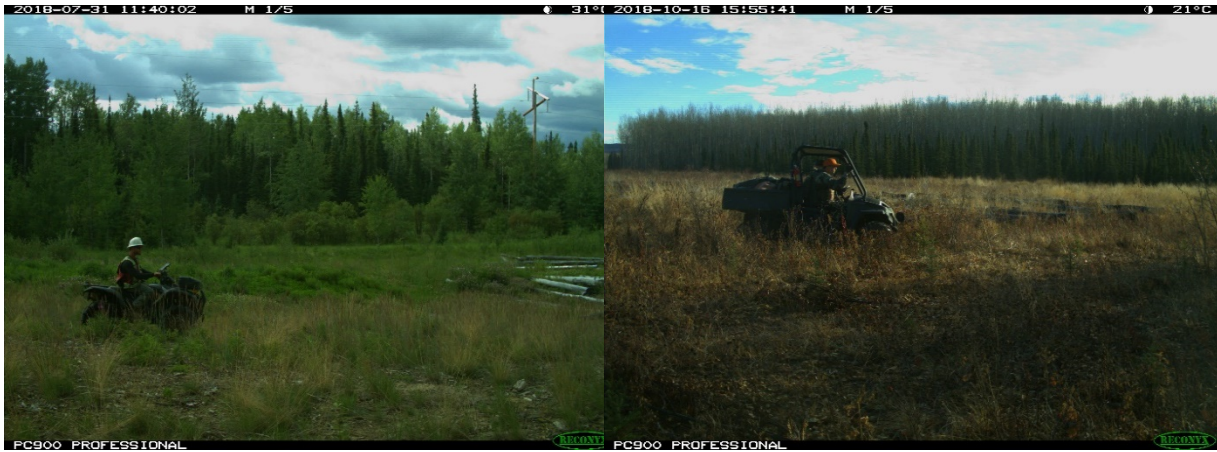
Observations of photos and tracks in the field indicated that some OHVs circumvented access controls by driving over the centre line or bypassed them by travelling along adjacent ROWs (i.e., power lines or adjacent pipelines), which remain outside of NGTL control.

**Photo 4-1: Example of a worker (left; wearing PPE) and a recreational user access (right; wearing camouflage and hunter high visible orange hat) by OHV.**

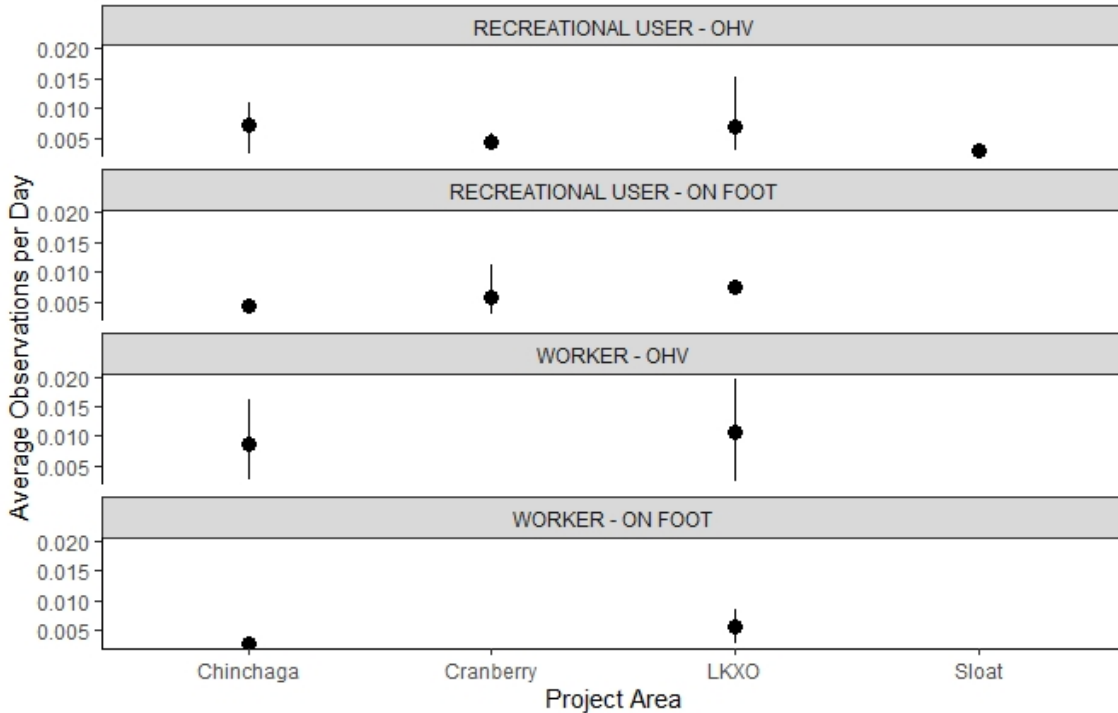
Figure 4-1: Average worker and recreational user observations (± SE) per day at access controls during the 2018/2019 observation period

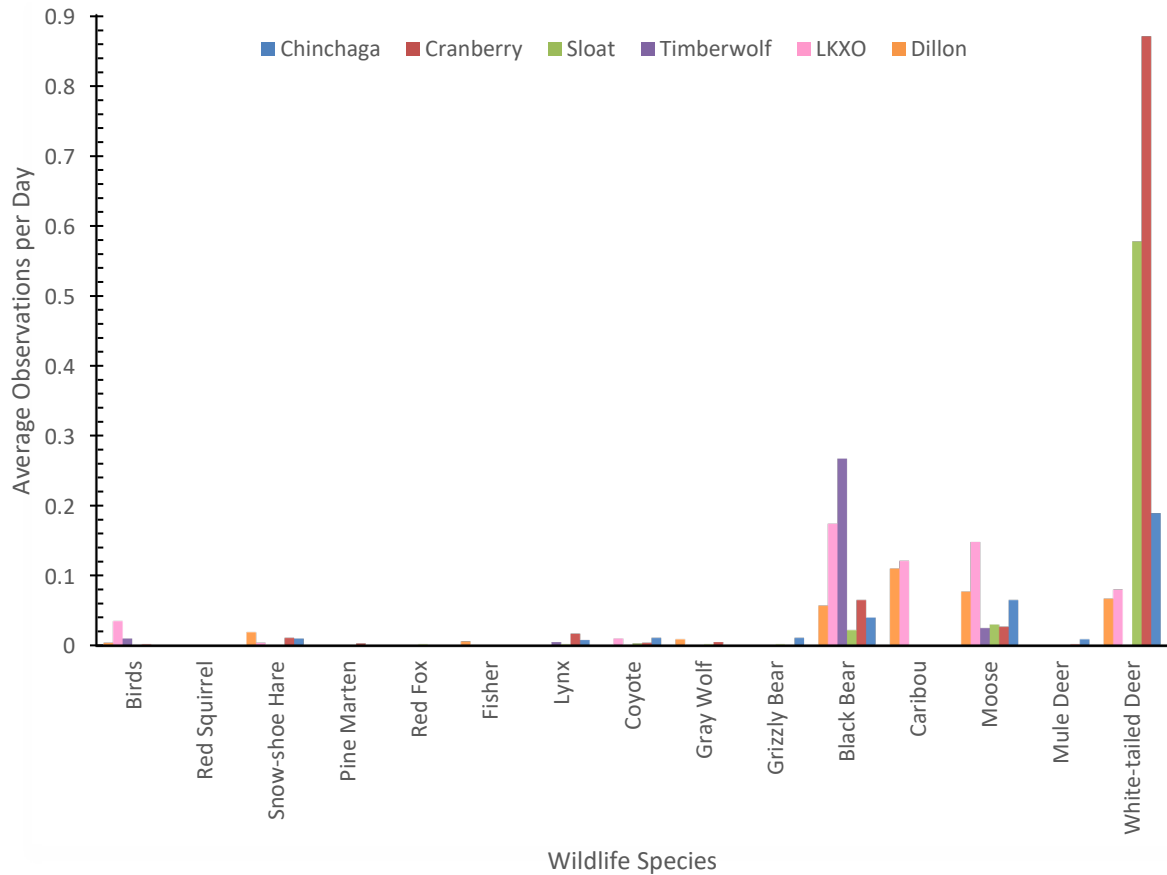
The average wildlife observations per day are presented by species are detailed in Figure 4-2. A detailed summary by species is provided in Appendix C. With one exception (C-04 on Cranberry), wildlife was observed at all camera locations. No obvious trend is apparent between the frequency of wildlife occurrence and the type of access control; total wildlife varied by camera for all Project areas. While the exact cause of variability is unknown, habitat characteristics are the most likely cause of species variation.

**Figure 4-2: Average wildlife observations by species per day for each Project Area.**

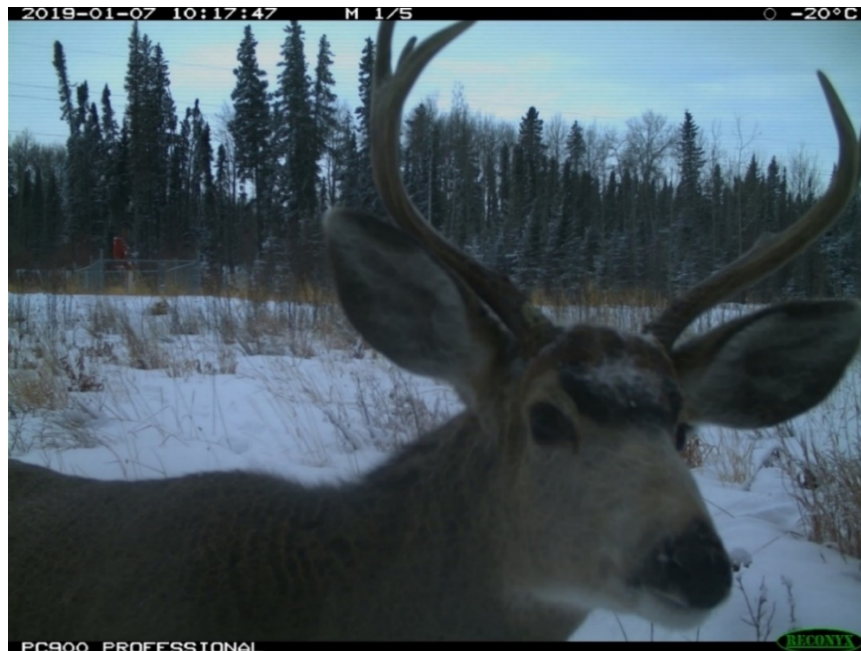
Photo 4-2: White-tailed deer buck photographed on Chinchaga (Chin-05)

Of all the species observed, white-tailed deer was the most abundant (*Odocoileus virginianus*: 0.067 to 0.870 observations per day; Photo 4-2), followed by moose (*Alces alces*: 0.025 to 0.148 observations per day; Photo 4-3), and black bears (*Ursus americanus*: 0.022 to 0.174 observations per day; Photo 4-4) No deer were observed on Timberwolf, while mule deer (*Odocoileus hemionus*) were observed infrequently on Chinchaga and Cranberry (0.002 to 0.009 observations per day).

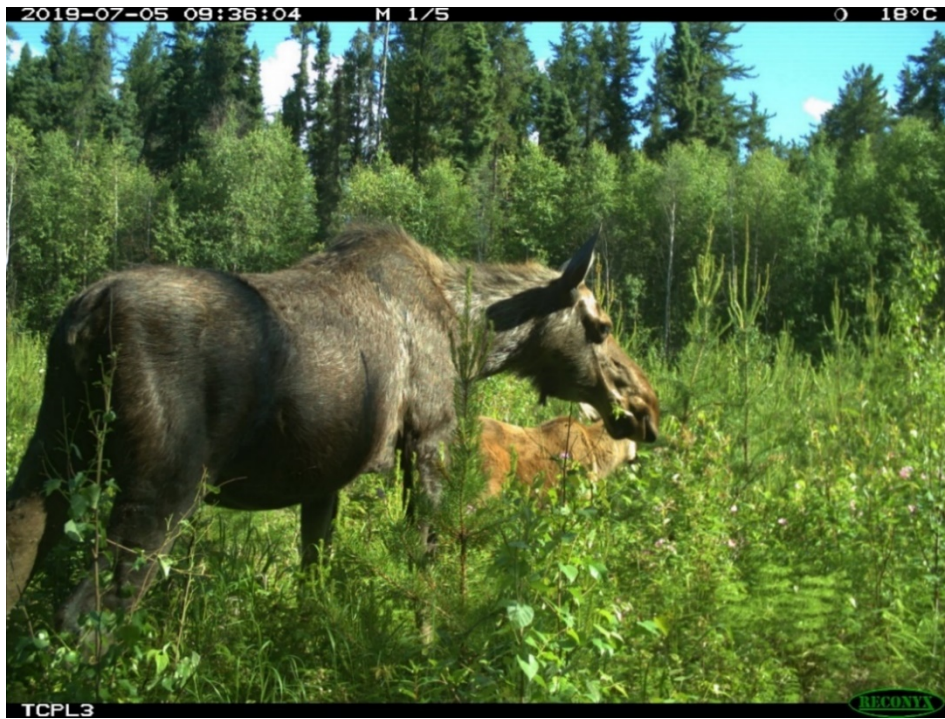
**Photo 4-3: Moose cow and calf photographed on LKXO (LKXO-03).**

Note the advanced revegetation stage of the ROW, with tall species transitioning to coniferous edge habitat in the background.

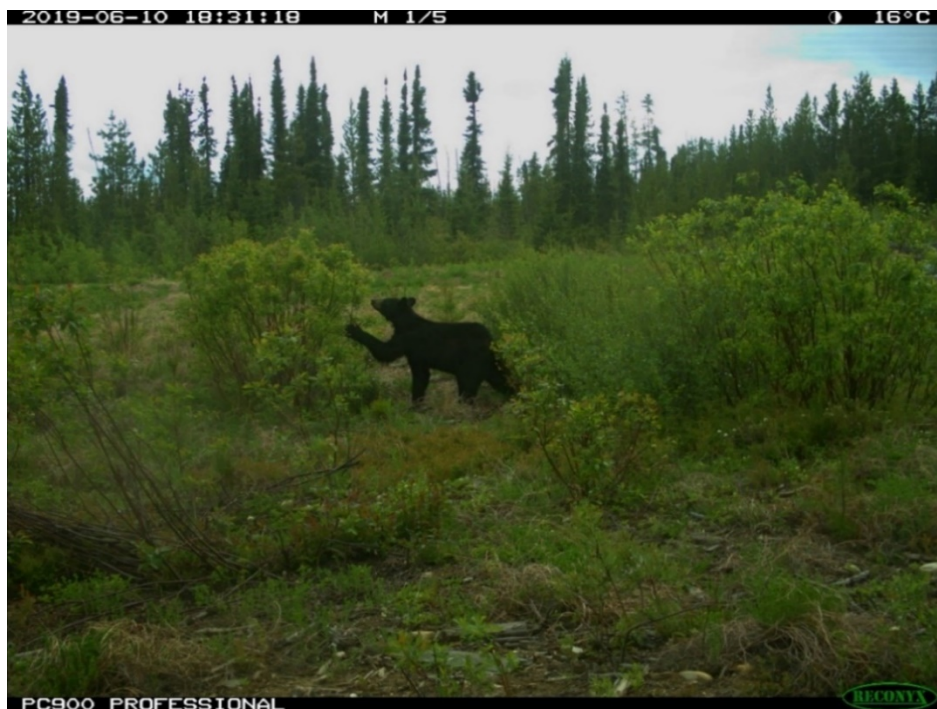
**Photo 4-4: Black bear photographed on Cranberry (C-05).**

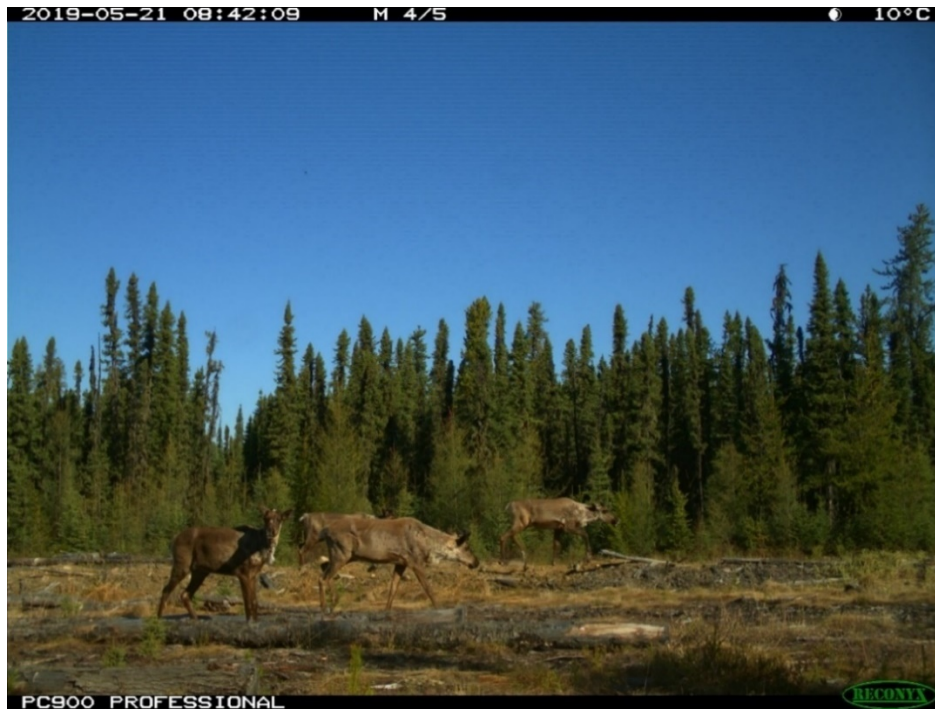
**Photo 4-5: Caribou on LKXO (LKXO-01). Following calving, caribou move between different habitats; herds are typically joined in the fall for the rut.**

A single woodland caribou was observed on the Cranberry ROW (0.0004 observations per day). Woodland caribou were observed more frequently and in greater numbers on the LKXO ROW and within the Dillon offsets, where suitable caribou habitat is widespread (Photo 4-5; 0.121 observations per day and 0.110 observations per day respectively).

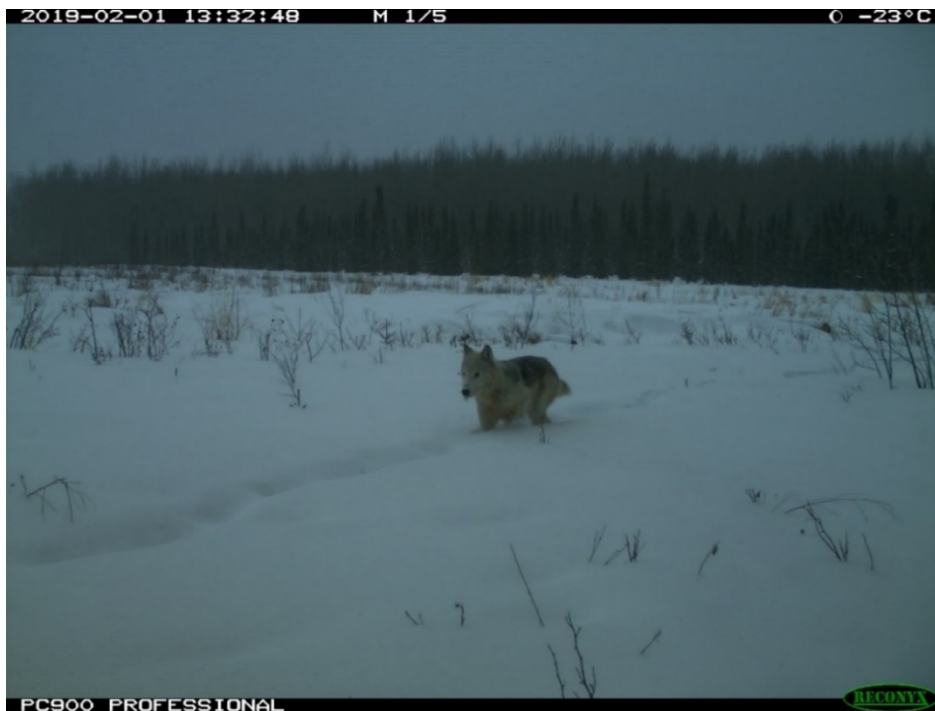
**Photo 4-6: Gray wolf on Cranberry (C-02)**

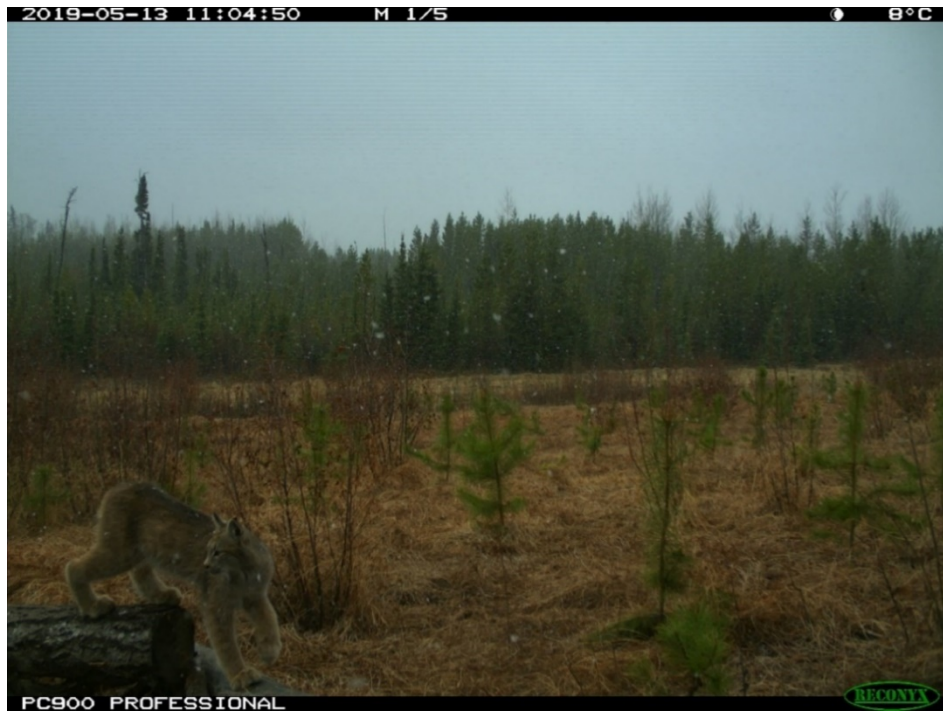
**Photo 4-7: Lynx photographed on Cranberry (C-06).**

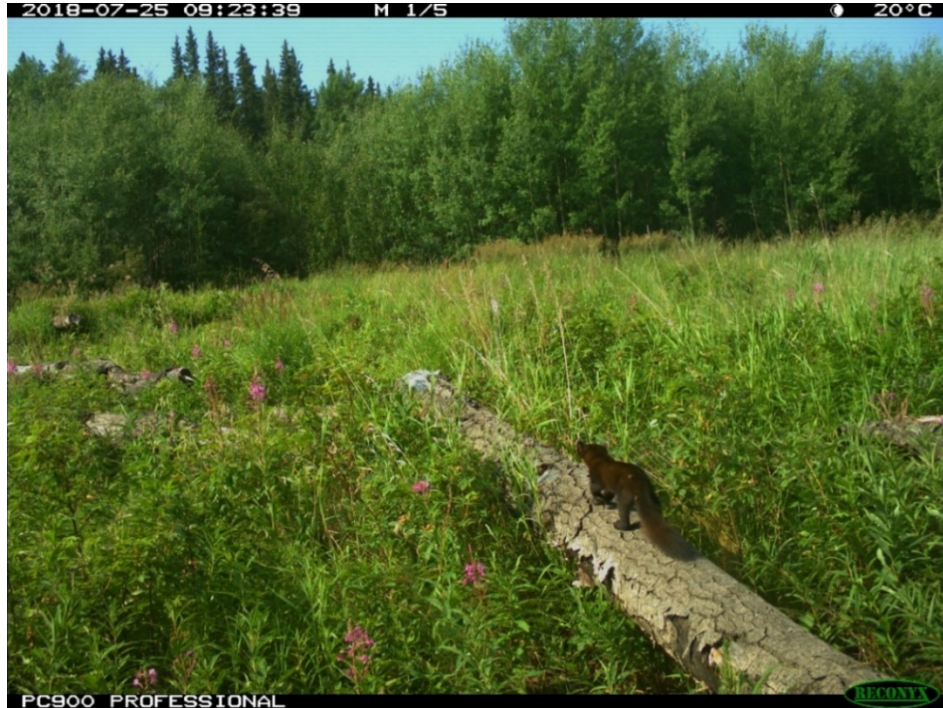
**Photo 4-8: Pine marten photographed on Chinchaga (Chin-07)**

*canadensis*), fisher (*Martes pennanti*), red fox (*Vulpes vulpes*) and pine marten (*Martes martes*) were also observed with varying low frequencies. Grizzly bears were only observed on Chinchaga, Cranberry and Sloat sections in low numbers (0.002 to 0.011 observations per day), but were not expected within LKXO and Dillon, which are located outside of grizzly bear range. Wolves (Photo 4-6), coyotes, and lynx (Photo 4-7) were also infrequent (wolves: 0 to 0.009 observations per day, coyotes: 0 to 0.011 observations per day, lynx: 0 to 0.017 observations per day) but were widespread overall (wolves and lynx were absent on LKXO and coyotes were absent on Timberwolf). Fishers were documented rarely at two Chinchaga and two Dillon cameras, red fox at a Chinchaga and a Sloat camera and pine marten (Photo 4-8) on a Chinchaga and a Cranberry camera.

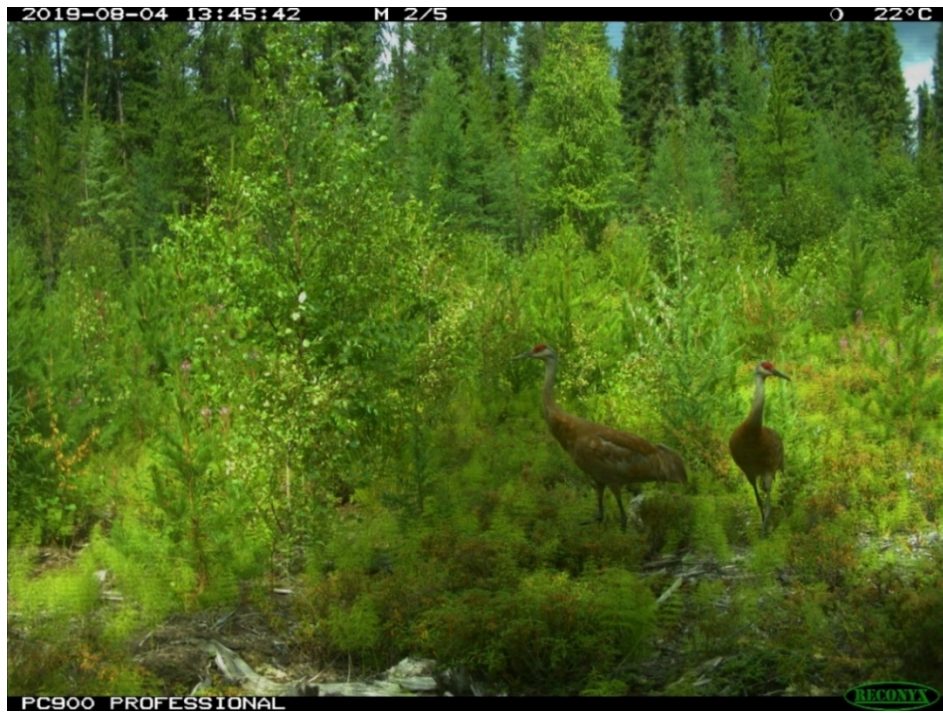
**Photo 4-9: Sandhill crane pair photographed on LKXO (LKXO-05)**

Snowshoe hare (*Lepus americanus*), red squirrel (*Tamiasciurus hudsonicus*) and various bird species were also documented during the monitoring period. Snowshoe hare were observed on Chinchaga, Cranberry, LKXO and Dillon cameras (0 to 0.019 observations per day). A single red squirrel was photographed on Chinchaga and various bird species were observed on all lines except Sloat. On LKXO and Dillon, birds were represented mainly by sandhill cranes (Photo 4-9; 48 observations or 0.135 observations per day on LKXO and 11 or 0.035 observations per day on Dillon). A single sandhill crane was also observed on Timberwolf.

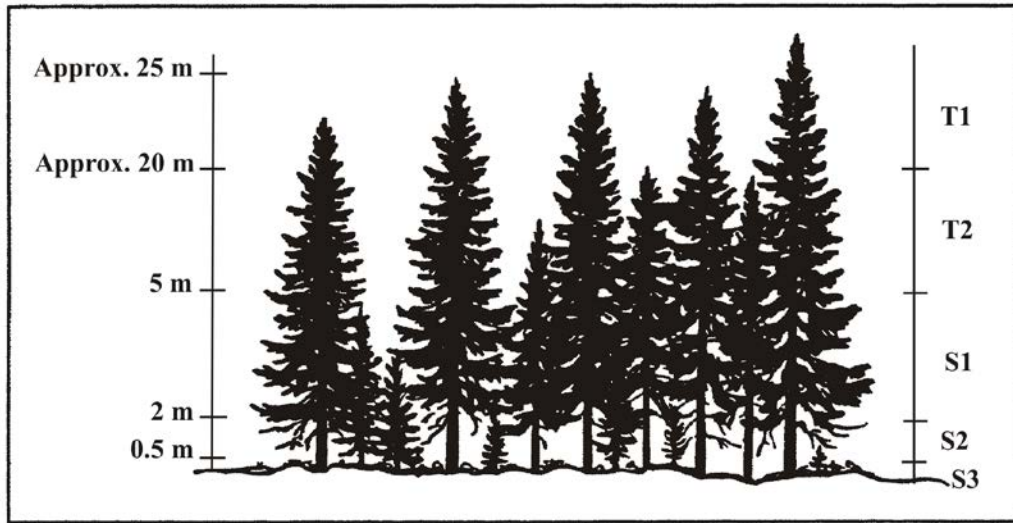
Figure B2 Stratification of Forest Stand, Shrubs and Trees (ASRD 2003)

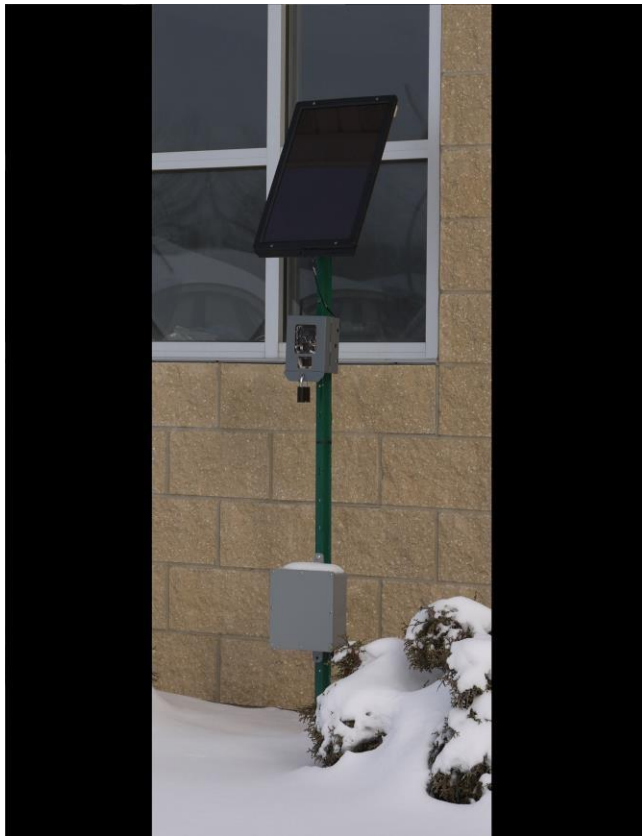
Photo 1: Example Camera and Solar Power Panel Pack Mounted on a T-post (© Reconyx)
