BGC ENGINEERING INC. AN APPLIED EARTH SCIENCES COMPANY	PROJECT: TRANS-MOUNTAIN EXPANSION PROJECT	
DATE:	AUG 2014		TITLE: TERRAIN MAPPING AND GEOHAZARD INVENTORY REVISION 1 MAP NUMBER 54 OF 54	
DRAWN:	JVC, IL		PROJECT No.: 009150	DWG No.: 54
CHECKED:	BW			
APPROVED:	AB

APPENDIX B

NATURAL HAZARDS SUMMARY TABLE

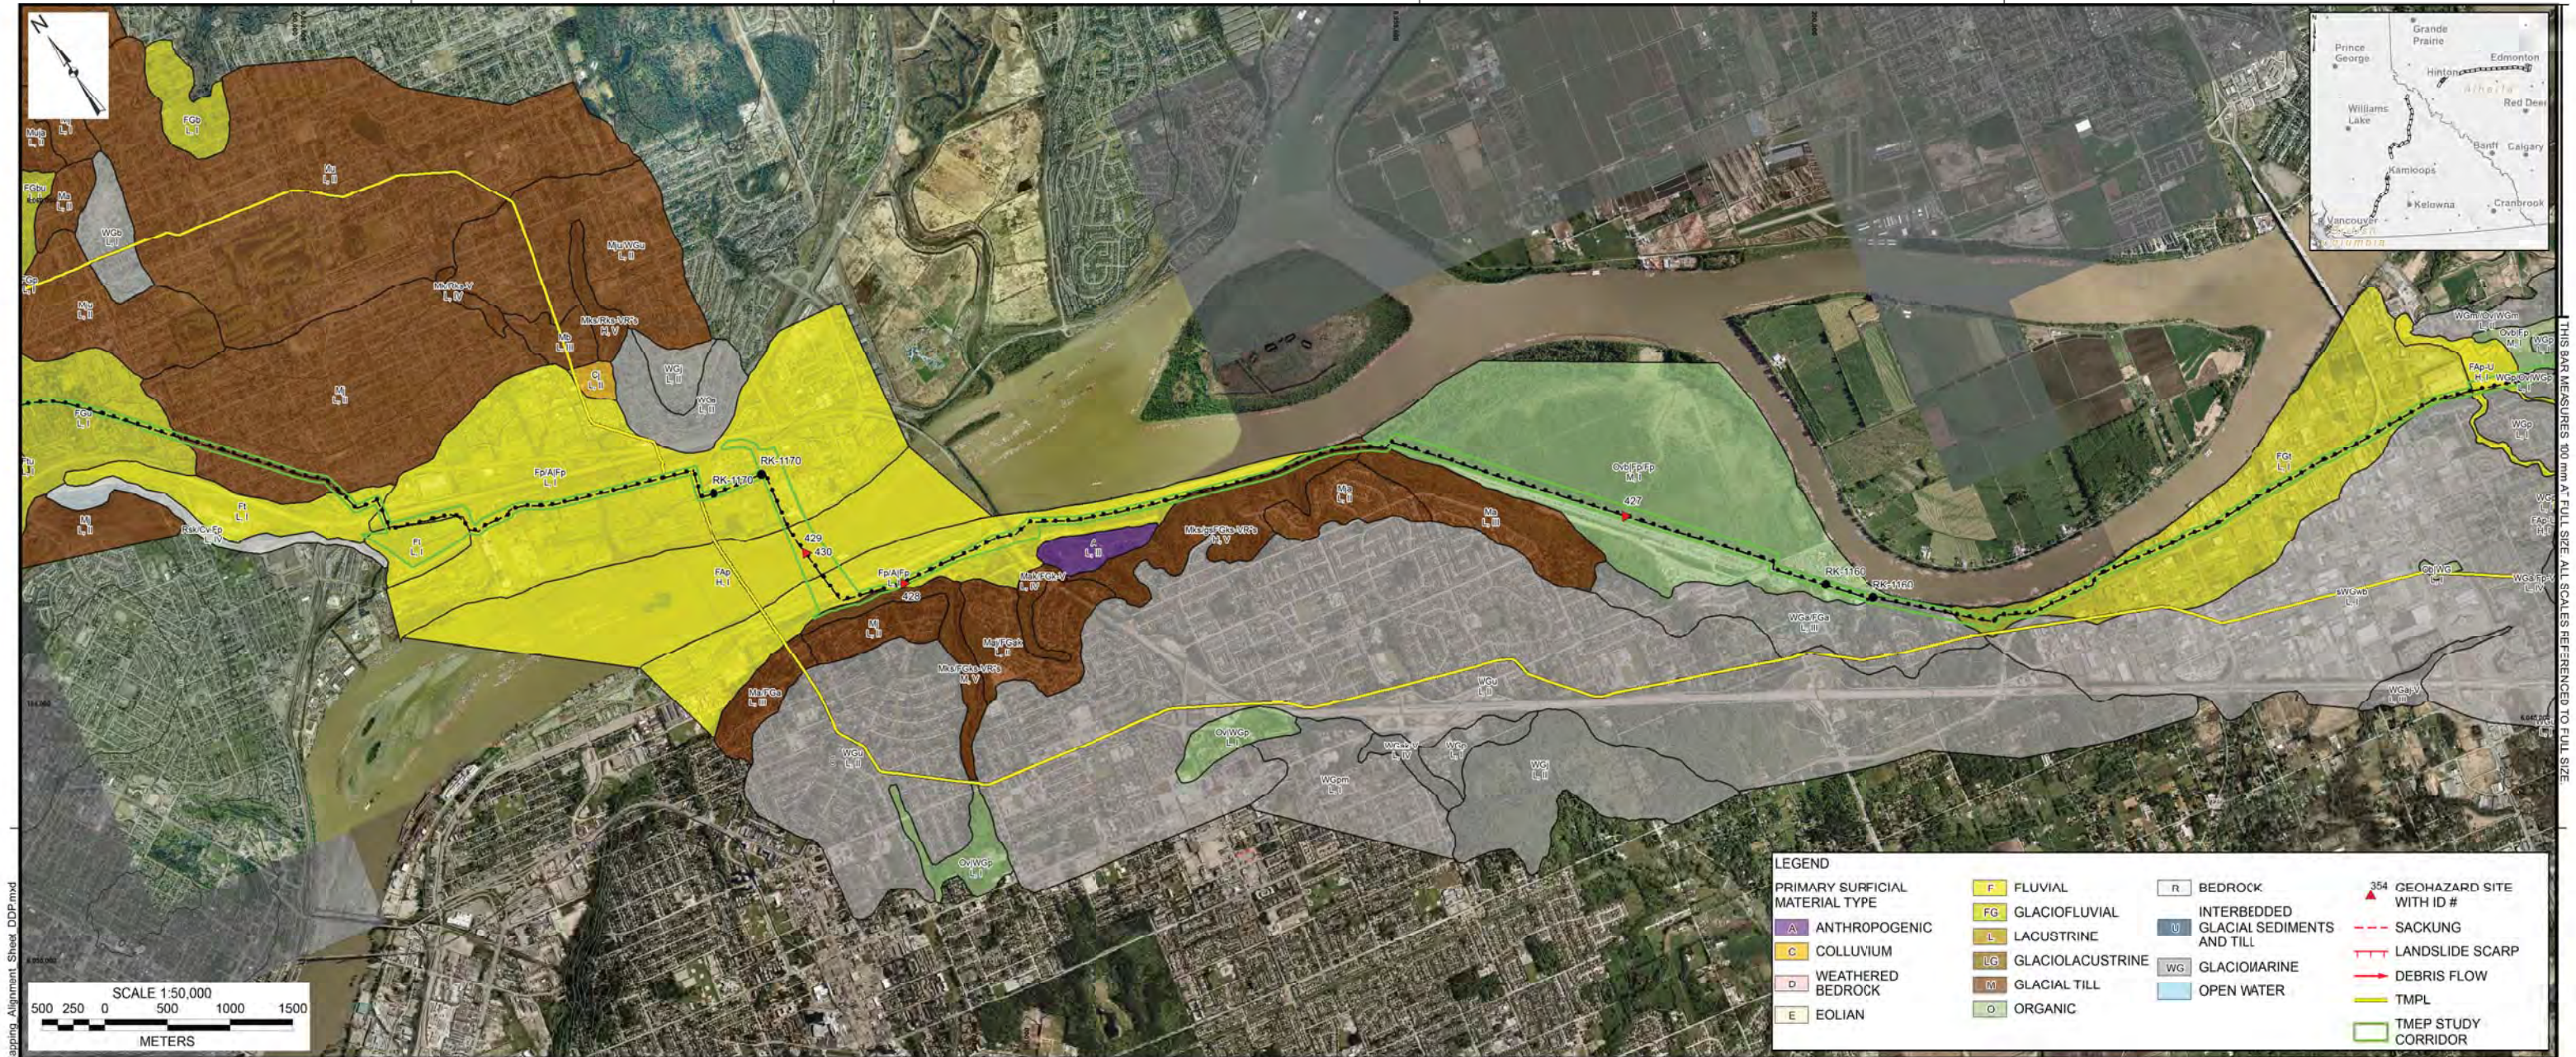
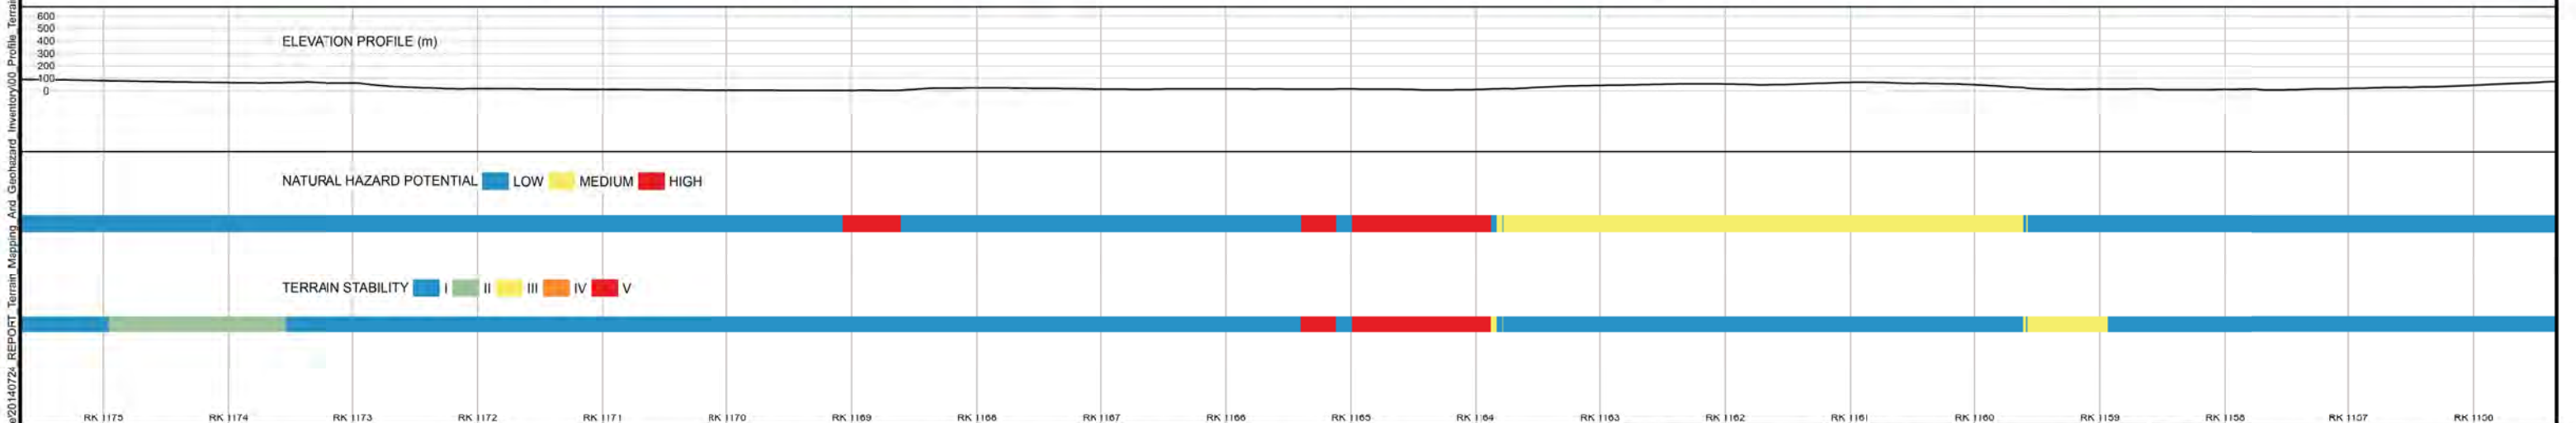
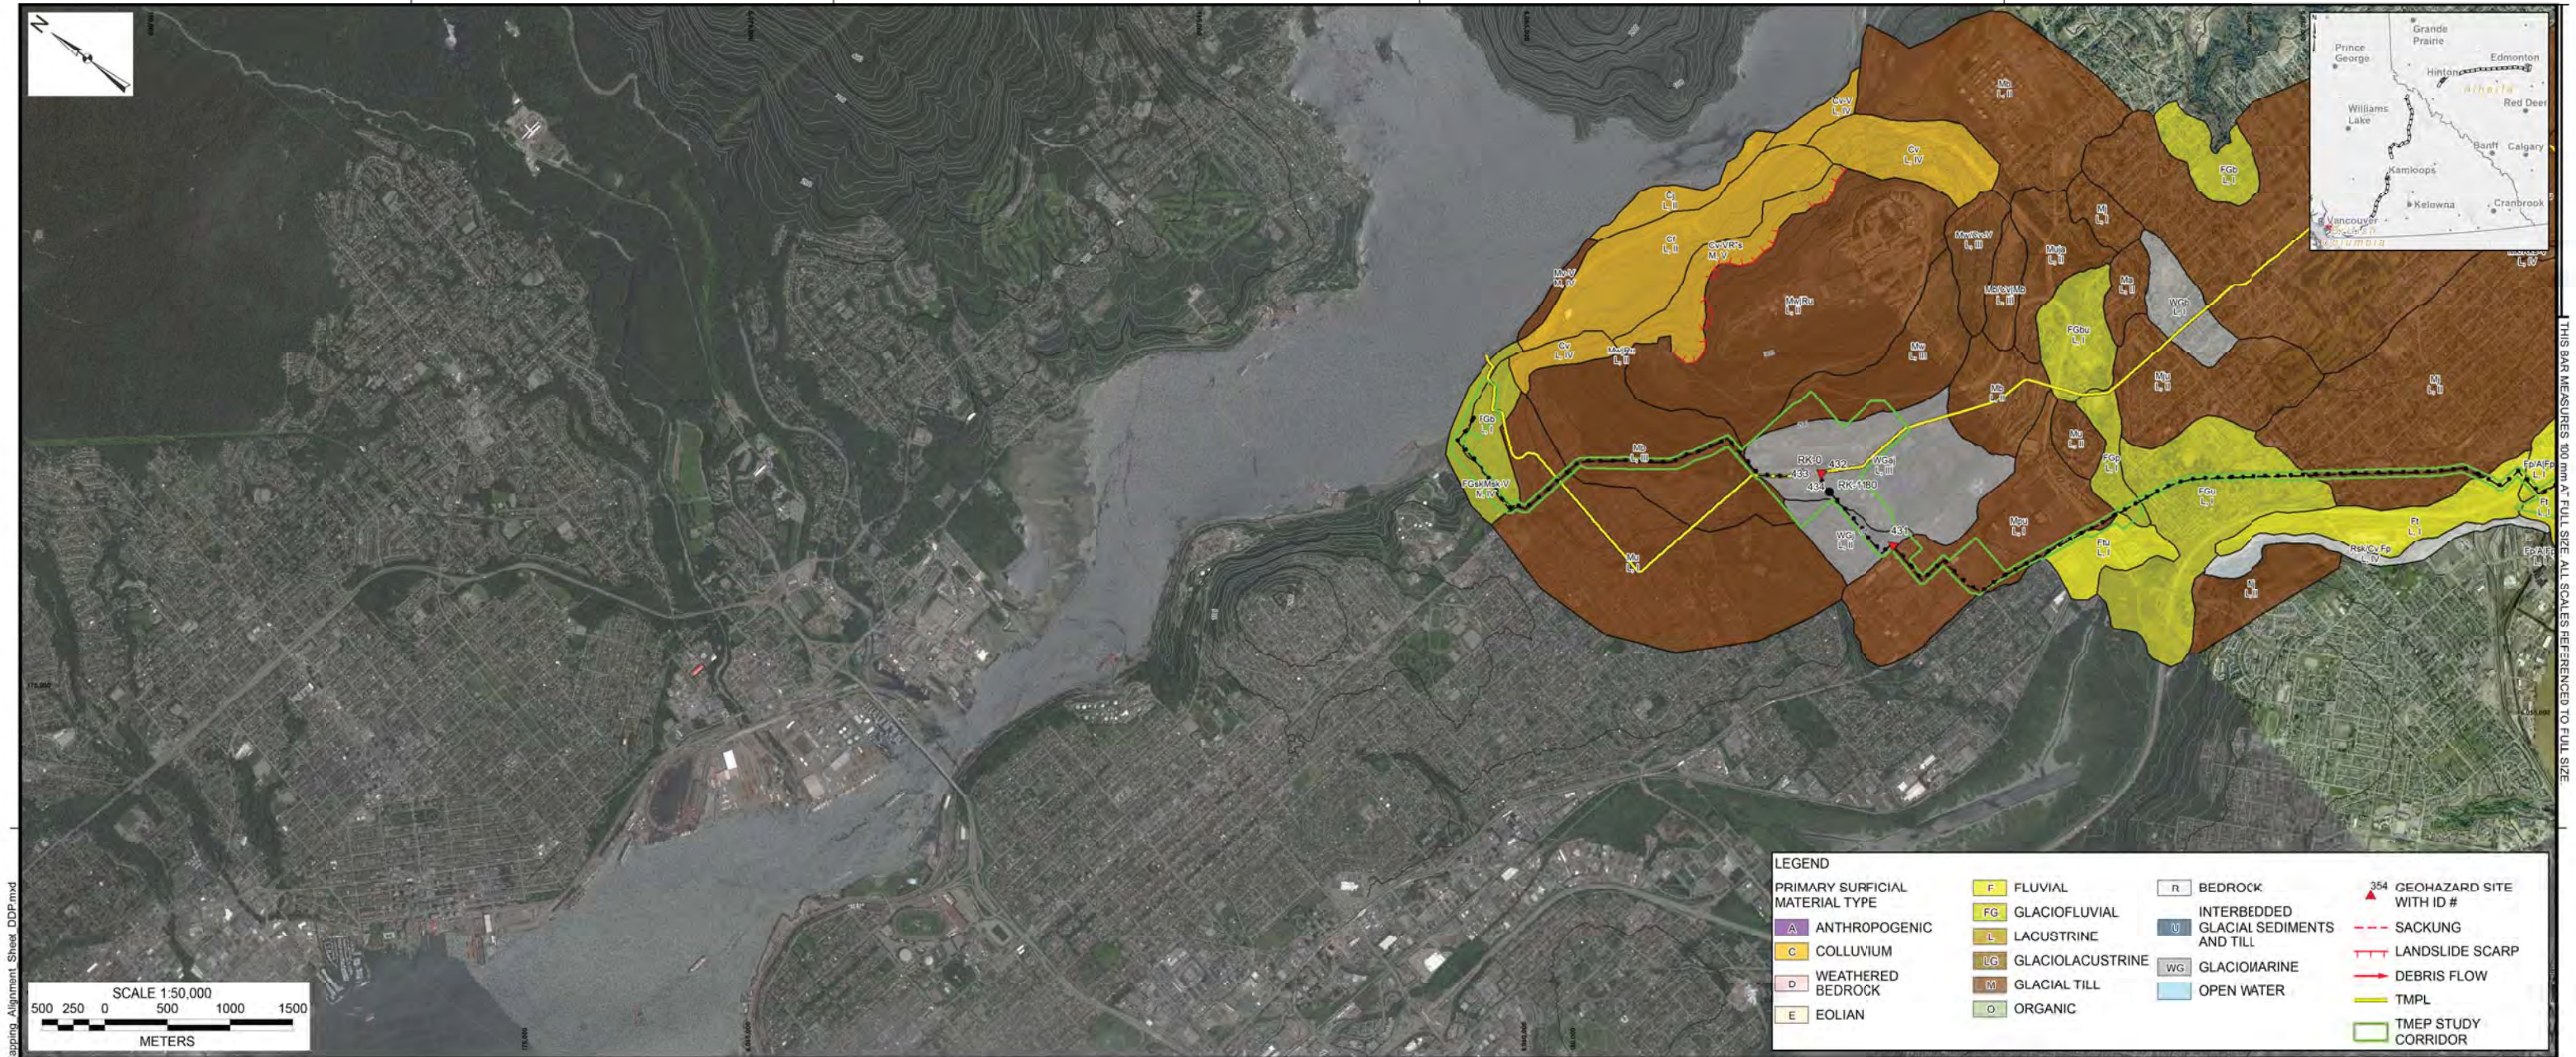
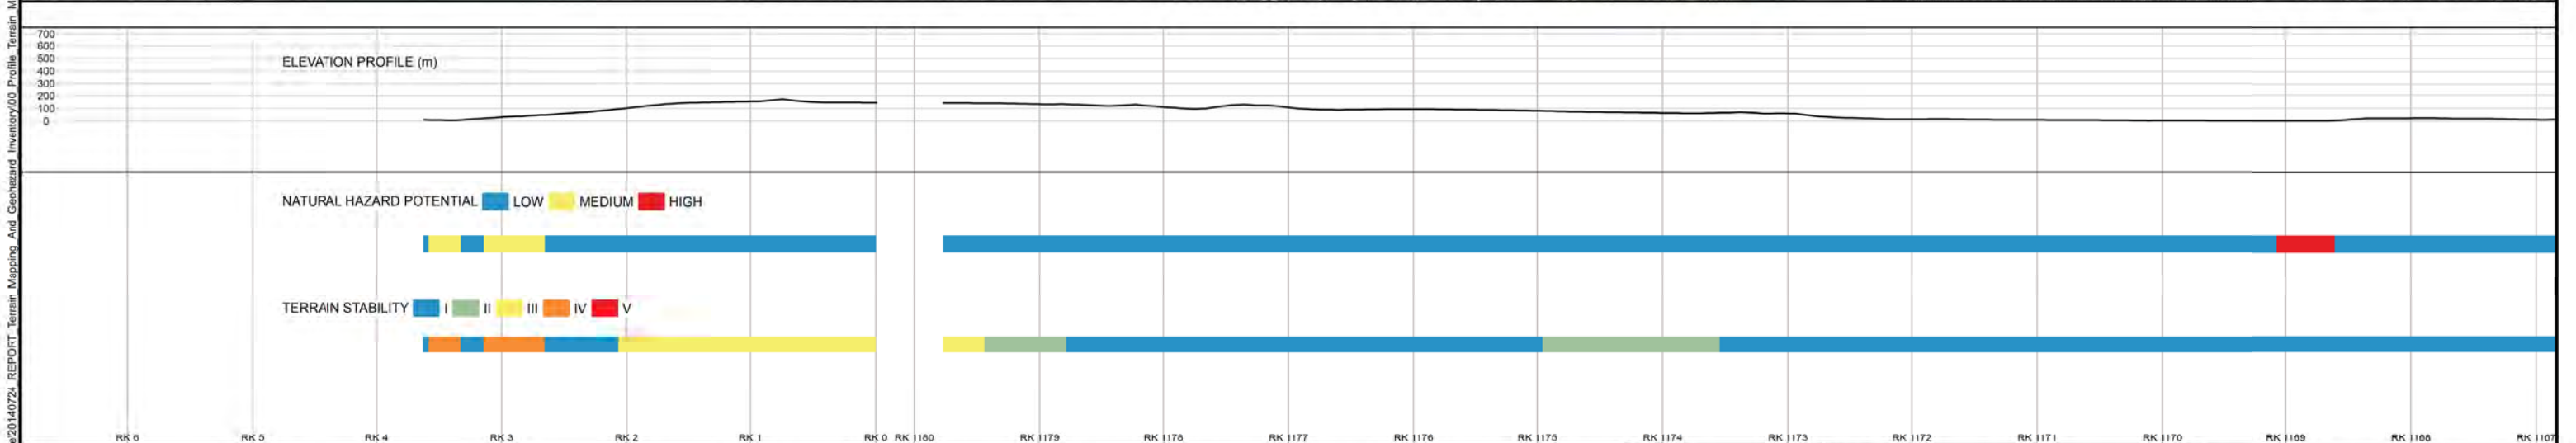
- ARROWED LANDSLIDE PATHS SHOW GENERAL SLIDE TRAJECTORIES. THEY DO NOT SHOW HAZARD EXTENTS. PATH ARROWS EXTEND INTO THE GENERAL RUNOUT ZONE BUT DO NOT REPRESENT THE MAXIMUM RUNOUT LIMIT.

- LANDSLIDE HAZARD EXTENTS ARE SHOWN BY SHADED POLYGONS. THEY SHOW EXISTING LANDSLIDE HAZARD INITIATION ZONE AND RUNOUT AREAS. POLYGON BOUNDARIES SHOULD BE REGARDED AS TRANSITIONS, NOT SHARP BOUNDARIES.
